1.0 Purpose

The purpose of this report is to provide a record of the performance of the CSD (Crew Systems Division) furnished equipment during the Apollo 11 mission. This report will include preflight, inflight, and post-flight problems, activities, and performance.

2.0 Apollo 11 EMU Hardware and Crew Provisions GFE (Government-furnished equipment)

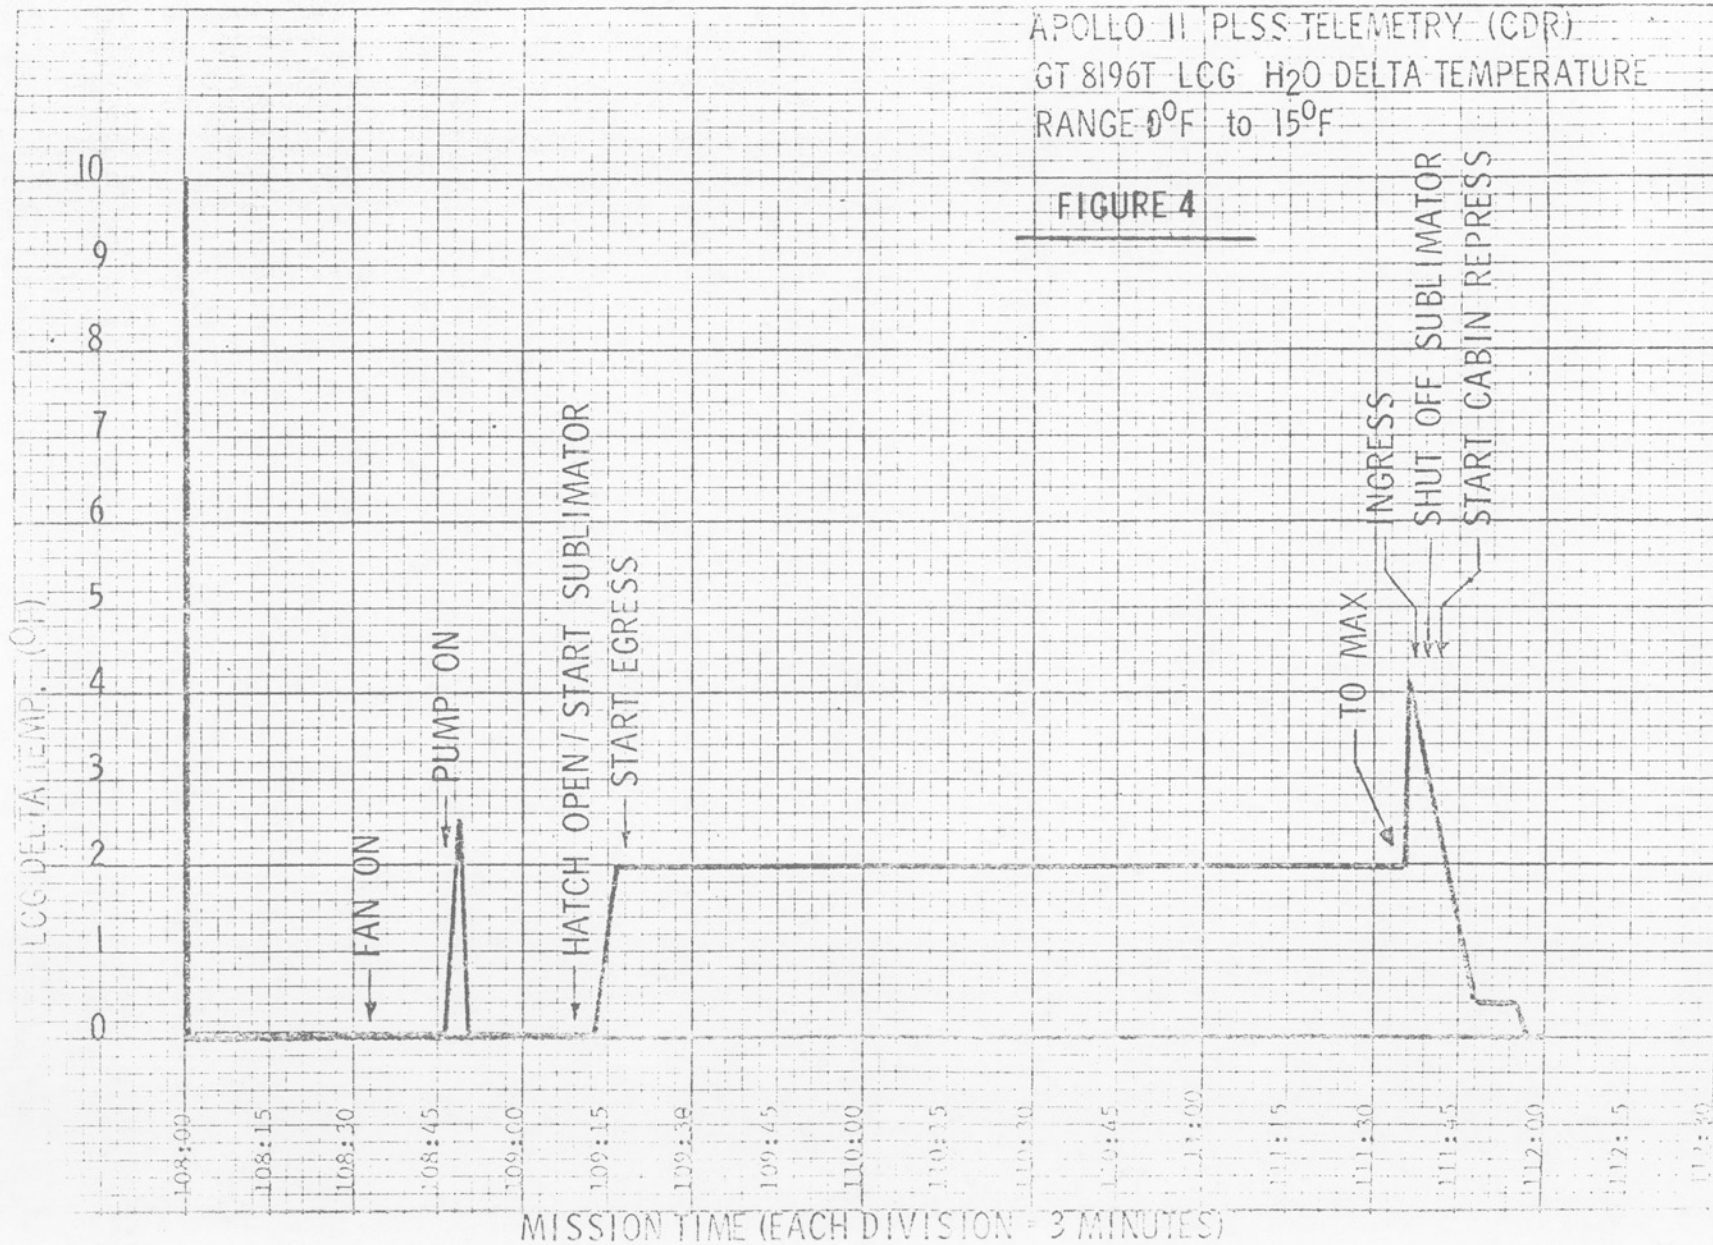
FIGURE 4

APOLLO II PLSS TELEMETRY (CDR)
GT 8196T LCG H₂O DELTA TEMPERATURE
RANGE 0°F to 15°F
